Sustainable Solutions for Conservation:
New Strategies for New Times
Soluciones Sostenibles para la
Conservación: Nuevas Estrategias para
los Nuevos Tiempos

Data Collection for Cultural Heritage Risk Management: the *Damage Map through Heritage Building Information Modeling (HBIM)* Project Applied to the Façade of St Francis of Assisi, Ouro Preto, Brazil

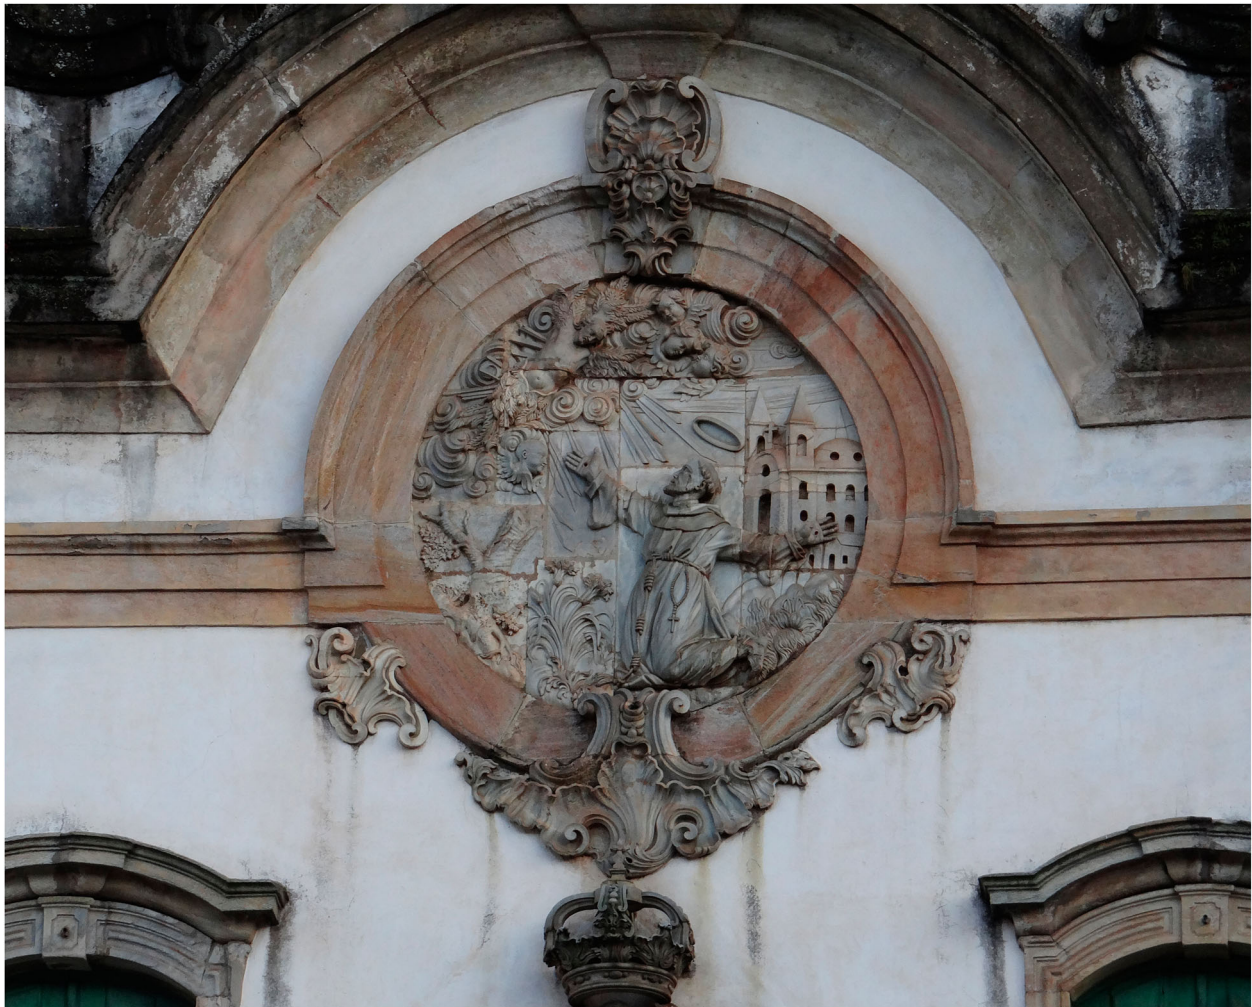
Figure 1. Façade of the church of St Francis of Assisi, Ouro Preto, Brazil. Image: the authors.

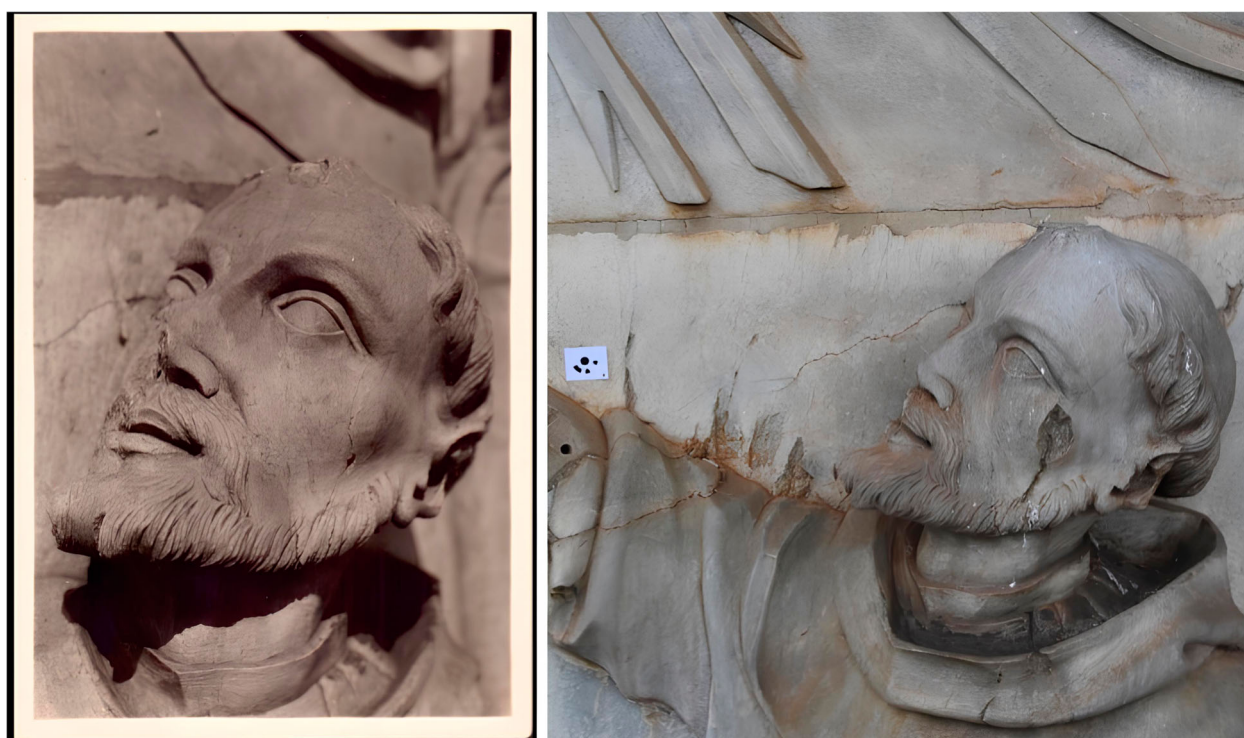
Figure 2. Detail of the face of St Francis of Assisi (a) 1937. Image: IPHAN (b) 2023. Image: the authors.

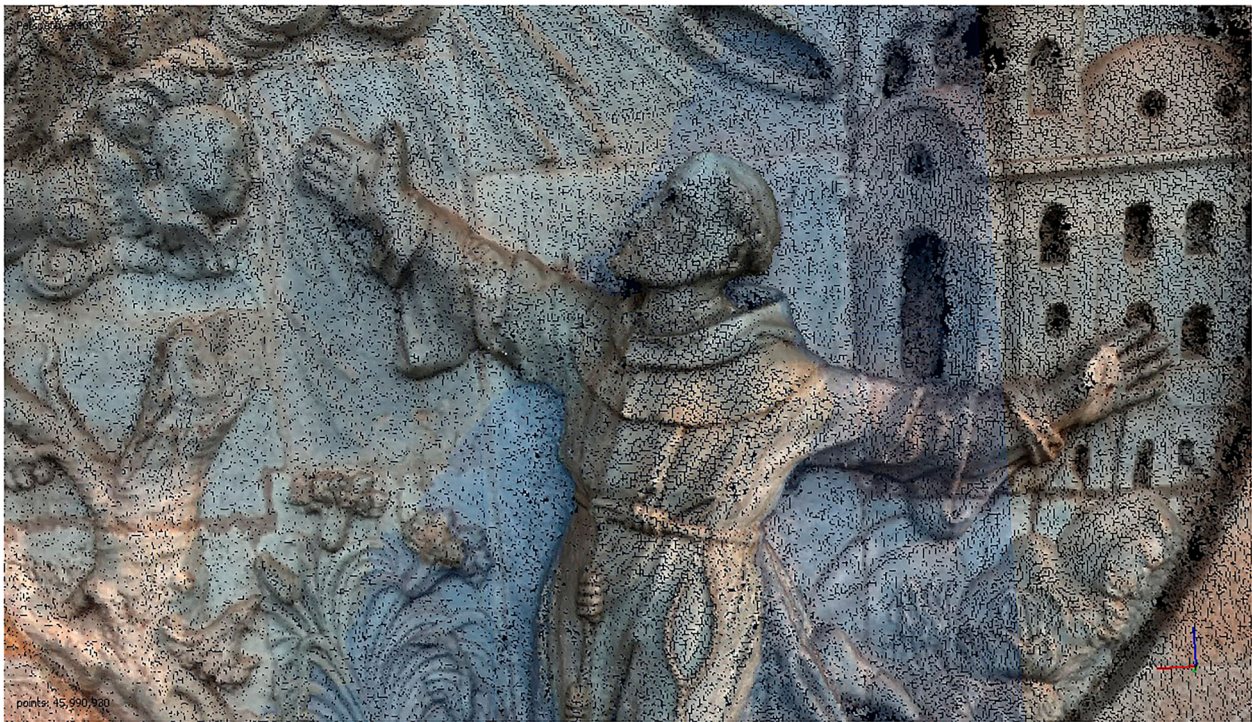
Figure 3. Details of the point cloud. Image: the authors

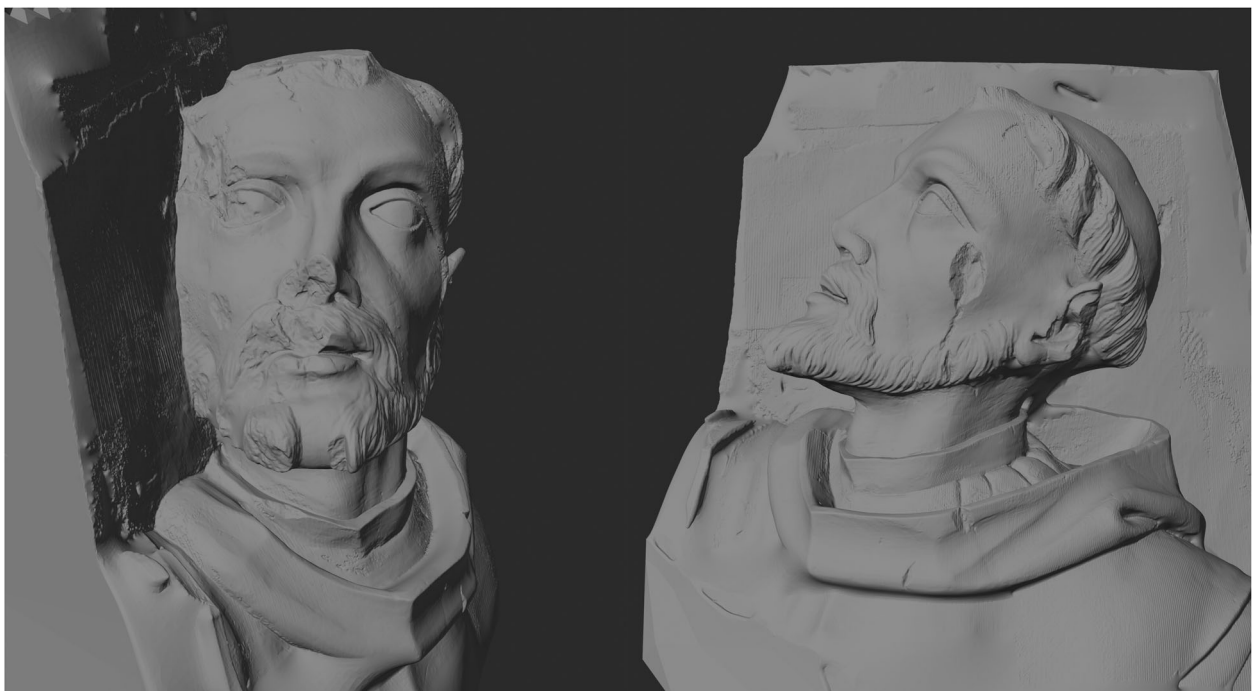
Figure 4. Losses on the nose, part of the lips, and cheekbone recorded in 3D modeling, (a) from the left side and (b) from the right side. Image: the authors

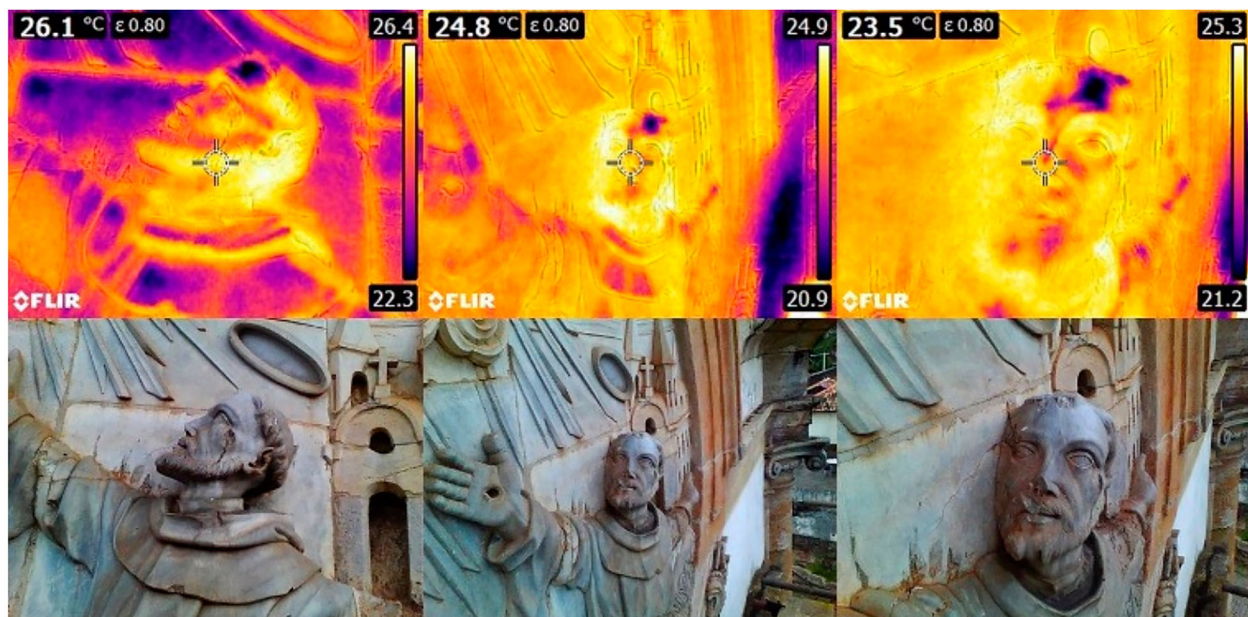
Figure 6. Compose image of the face of St Francis, obtained from different angles by FLIR-E5. Image: the authors
