Calf Augmentation Implant Disruption Following a Tibial Plateau Fracture Fixation: An Extremely Rare Complication

Robinson E Pires^{1,2}, Gustavo Waldolato², Egidio O Santana Jr.²,
André Wajnsztein³, Pedro J Labronici⁴, Vincenzo Giordano⁵

Pires R E , Waldolato G, Santana E O Jr., Wajnsztein A, Labronici P J, Giordano V. Calf Augmentation Implant Disruption Following a Tibial Plateau Fracture Fixation: An Extremely Rare Complication. *Journal of Orthopaedic Case Reports* 2019 Sep-Oct; 9(5): 91-94.

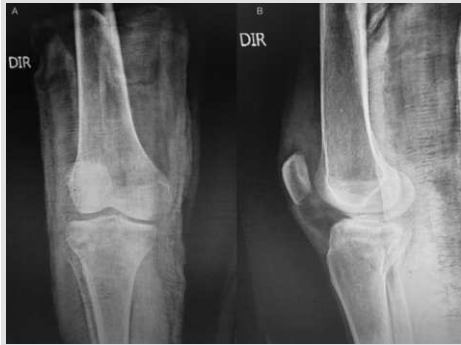
Figure 1: X-ray in anteroposterior (a) and lateral (b) views showing a bicondylar tibial plateau fracture (Schatzker V).

(Fig. 1 and 2) depict pre-operative images.

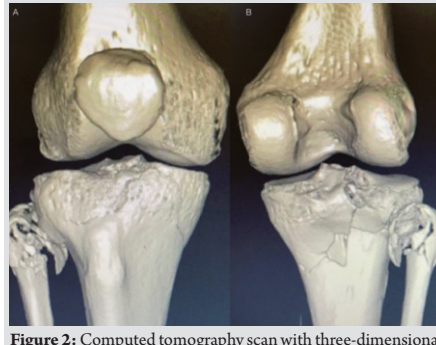
Figure 2: Computed tomography scan with three-dimensional reconstruction (a and b) showing the bicondylar tibial plateau fracture. Note the posterior column impairment.

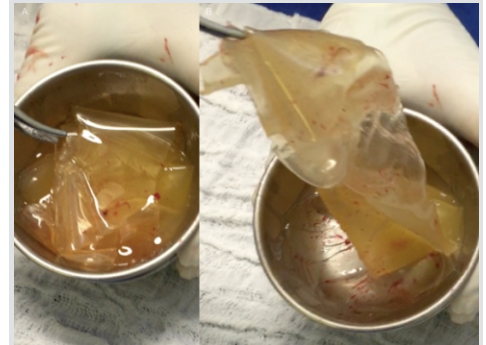
Figure 3: (a and b) Perioperative image showing calf augmentation implant disruption.

pusher and K-wires provided provisional fixation. A t-shaped distal radius plate was placed at the posteromedial surface of the tibial plateau to buttress the fracture. During the most distal plate hole drilling, we observed a high volume of silicone drainage. We decided to keep the plate and carefully debrided the wound, removing all the silicone and calf implant. After extensive debridement, we completed the posteromedial fixation and removed the bump to achieve supine position and permit anterolateral fixation. An anterolateral approach was performed, and an L-shaped locked plate fixed the anterolateral fragment.

(Fig. 3) depicts calf augmentation implant disruption. (Fig. 4) shows fracture reduction and fixation with plate and screws.

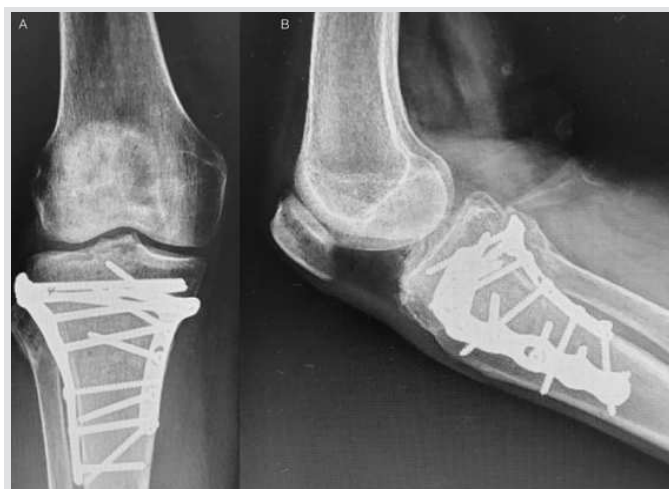
Figure 4: X-ray in anteroposterior (a) and lateral (b) views showing fracture fixation with a posteromedial buttress plate and precontoured anterolateral locked plate.

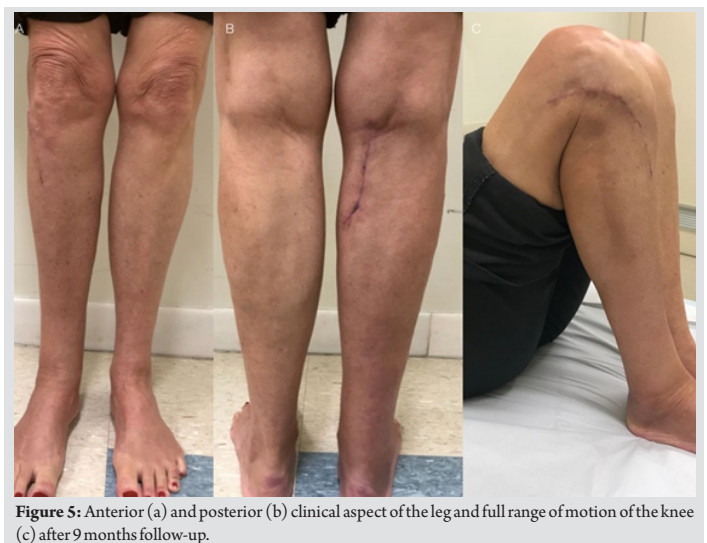
Figure 5: Anterior (a) and posterior (b) clinical aspect of the leg and full range of motion of the knee (c) after 9 months follow-up.

Knee Society Score function after 9 months was 80 points (Fig. 5).
