Lignin-modified road marking paint: weathering aging studies

The accelerated artificial aging with ultraviolet radiation, viscosity, density, no-pick-up time, flexibility, and abrasion resistance of lignin-modified road marking paint were evaluated. The addition of lignin did not cause significant changes in the physical chemistry, flexibility and no-pick-time test compared to the precursor paint. The addition of 1.00 wt. % of lignin increased the abrasion resistance by 36%. The Fourier Transform Infrared technique performed before and after exposure to Weather-o-meter aging chamber has shown the cleavage of ester groups that are present in acrylic-based resin. The incorporation of 0.10 wt.%, 0.25 wt.%, and 1.00 wt.% increased the photodegradation resistance of the road marking paint inhibiting the ester group and side-chain scissions, since the C-O and C=O band intensity increased after irradiation. The introduction of lignin delayed the yellowing of the aged samples and improved mechanical and photophysical properties besides being a good strategy for the biomass waste utilization of the paper industry.

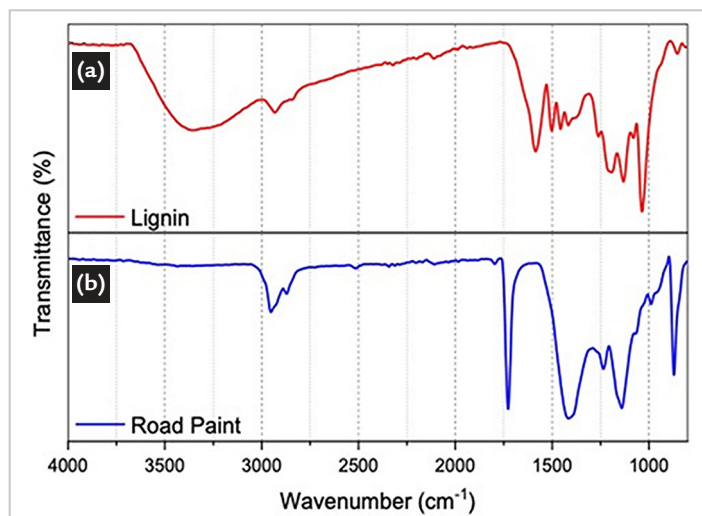
The FTIR spectra of lignin and road paint are shown in Figure 1. The FTIR spectrum of lignin (Fig. 1a) showed the O-H functional group at 3366 cm⁻¹ indicating water absorption, and a strong

broad C-H stretching at the 2934 cm⁻¹. In the 1900 and 900 cm⁻¹ regions, several absorption bands are noticed due to the functional groups constituent of the lignin as shown in Table 1. The bands at 1584

obtained in this study. Figure 1(b) shows a FTIR spectrum of RM paint which typical bands are described in Table 2.

Figure 1- FTIR spectra of (a) lignin and (b) dried road marking paint.

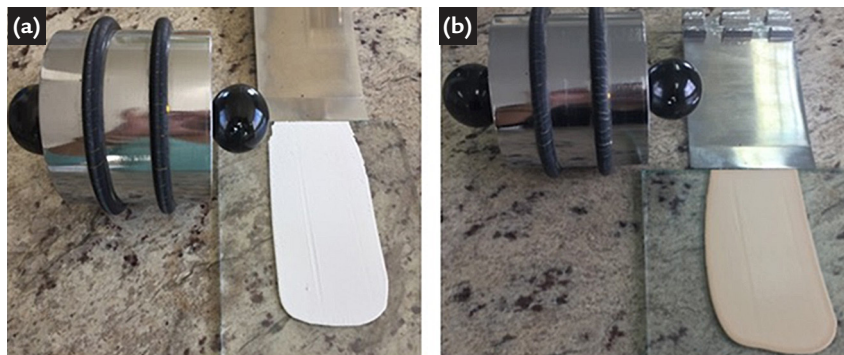
Standard acrylic demarcation paint samples containing 0.10%, 0.25% and 1.00% of lignin had the same average drying time value (12

minutes). This time was sufficient for painting the plate and performing the test, since the paint was not adhered to the steel cylinder rubbers, as can

be seen in Figure 2. In this study, the amount of lignin added to paint was small and did not influence the drying time.

Figure 2 - Images of the no-pick-up time test for samples (a) without lignin and (b) containing 1.00 wt. %.

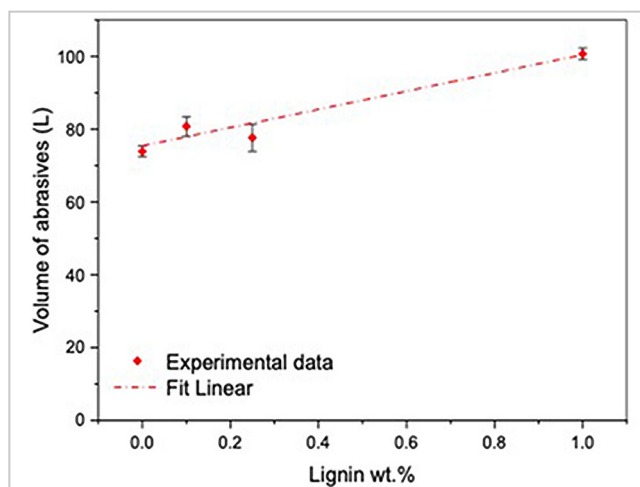
Figure 3 - Variation of the average volume of abrasives (l) in relation to the percentage of added lignin.

volume and reinforcing the structure formed in a level molecular. Thus, mixing small amounts of lignin in the paint improved the wear resistance of the resulting product, as can be seen from the increased abrasive volume shown in Figure 3.

The addition of 1.00 wt. % of lignin increased the abrasion resistance by 36%.

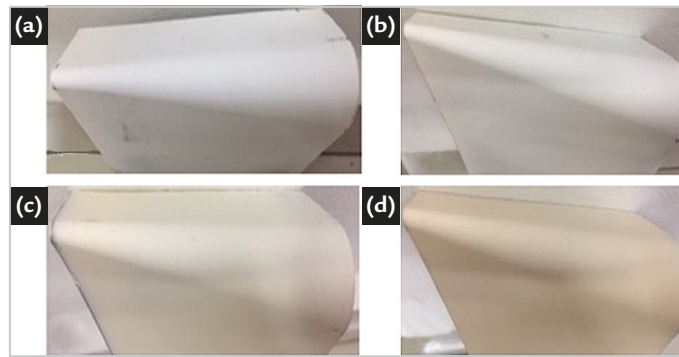
In the flexibility test, one of the qualitative requirements of road marking paint, the result obtained was satisfactory. According to Figure 4, there

was no cracking or peeling of the paint after folding the plates around the metal cylinder. Lignin contains many benzene rings, methyl groups and a small number of aliphatic groups in the side chain. Such groups present in the lignin structure improve the flexibility of road paint (Yan *et al.*, 2018). However, according to Yan *et al.* (2018), when the amount of lignin added to the resin is higher than 5.00 wt.%, the amount of benzene rings

addition up to 1.00 wt.% in road paint did not affect its flexibility.

Figure 4 - Road marking paint, after flexibility test, with contents of: (a) 0 wt.% lignin; (b) 0.10 wt.% lignin; (c) 0.25 wt.% lignin; and (d) 1.00 wt.% lignin

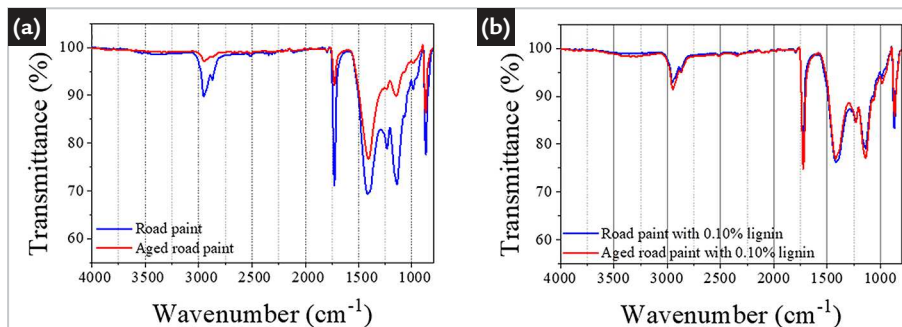
celerated aging using a Xenon Arc lamp whose spectral range is comparable to the outdoor solar radiation (Bellamy, 1975). Figure 5 and Figure 6 show FTIR spectra

of water-based RM paint with lignin addition (0.10, 0.25, and 1.00 wt.%) and without lignin, before and after exposure to the arc xenon lamp radiation.

Figure 5 - FTIR spectra of road marking paint and aged road paint containing (a) 0.00 wt.% lignin, (b) 0.10 wt.% lignin.

Chiantore *et al.* (2000) associated the decrease in intensity of bands of acrylic resin in the region 2800 cm^{-1} to the loss of low molecular weight material generated by photodegradation. Absorptions at 2800 cm^{-1} showed a slight increase after aging for lignin-modified paints (Figure 5 and Figure 6). Only the road marking paint without lignin showed a decrease in intensity of bands at 2800 cm^{-1} , indicating a photodegradation with a loss of low molecular weight material (Fig. 5 and Fig.6).

bands in this region (Figure 5 and Figure 6). The reactions promoted by the high-energy radiation (higher than 290 nm) are homolyzes of all types of chemical bonds, bringing the polymer structure to complete fragmentation (Melo *et al.*, 1999).

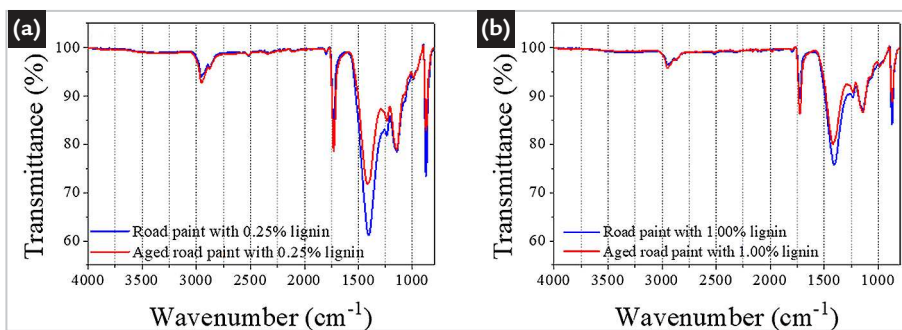
Figure 6 - FTIR spectra of road marking paint and aged road paint containing (a) 0.25 wt.% lignin, and (b) 1.00 wt.% lignin.
