**INFLUENCE OF PIPE SURFACE GRINDING ON FATIGUE LIFE OF  
SEAMLESS LINE PIPE API X65QS/QO PSL2 OFFSHORE**

**INFLUÊNCIA DO ESMERILHAMENTO NA SUPERFÍCIE DO TUBO NA  
VIDA EM FADIGA DE TUBOS DE AÇO SEM COSTURA X65QS/QO  
OFFSHORE**

Dissertação apresentada ao Programa de Pós-Graduação em Engenharia Metalúrgica, de Materiais e de Minas da Escola de Engenharia da Universidade Federal de Minas Gerais, como requisito parcial à obtenção do título de mestre em Engenharia Metalúrgica, Materiais e de Minas.

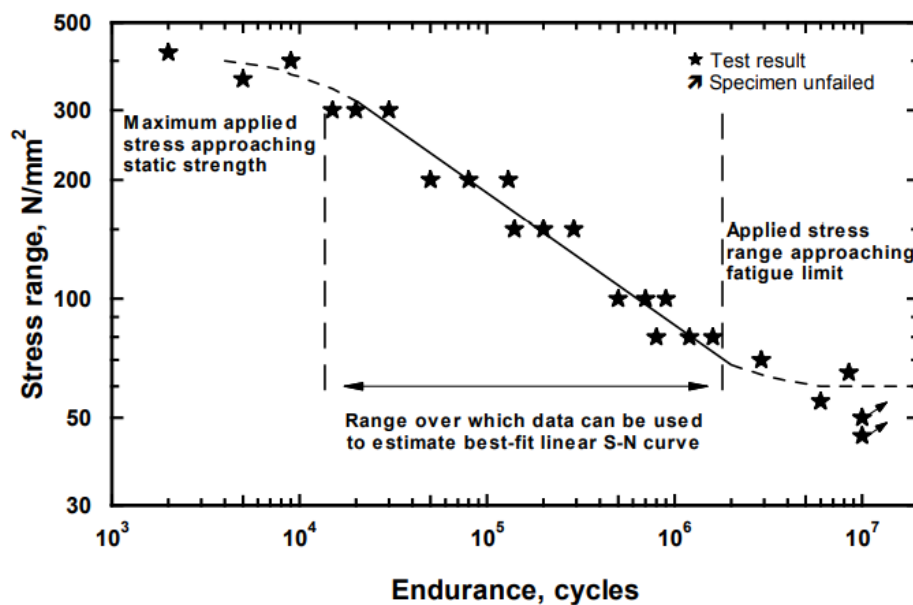
**Figure 3.11** - Typical fatigue endurance test data illustrating deviations for a linear  $S$ - $N$  curve [30].

This assumption will only hold true for certain limits of stress amplitudes, as illustrated in Figure 3.11. The lower limit on  $S$  is determined by the fatigue endurance limit (or just 'fatigue limit'), such that fatigue failure will not occur for lower stress ranges. In practice, this is usually chosen based on the endurance that can be achieved without any evidence of fatigue cracking, typically for  $2 \times 10^6 < N < 10^7$  cycles. The upper limit of  $S$  depends upon the static yield strength of the tested material and is commonly taken to be the maximum allowable static design stress [30].

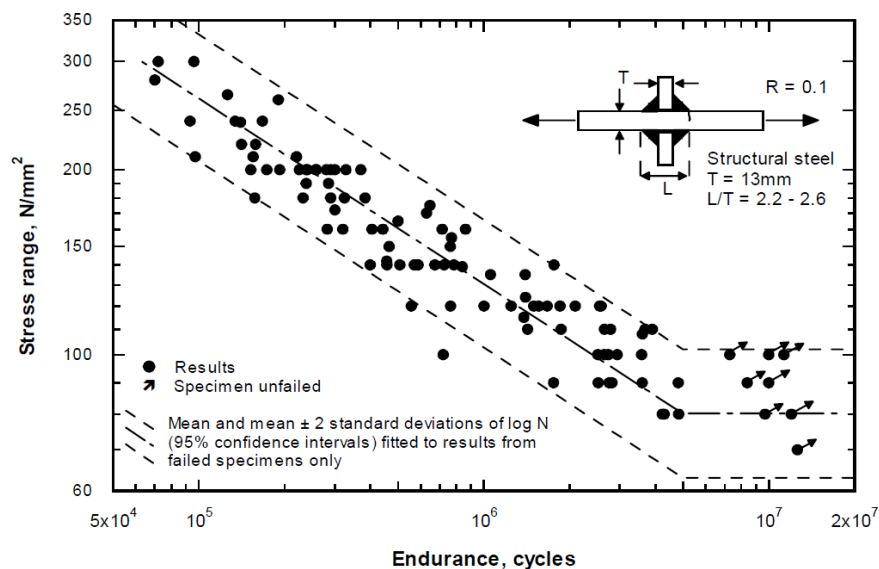
**Figure 3.12** - Example of  $S$ - $N$  data [30].

According to Schneider & Maddox [30],  $S$ - $N$  data comprise  $n$  data points  $(\log S_i, \log N_i)$ , where  $S_i$  is the stress range and  $N_i$  is the endurance in cycles. This endurance is either the number of cycles to failure (or some pre-determined criterion, such as the attainment of a particular size of fatigue crack) or the number of cycles endured without failure. Figure 3.12 shows an example of such data, with some fitted  $S$ - $N$  curves.

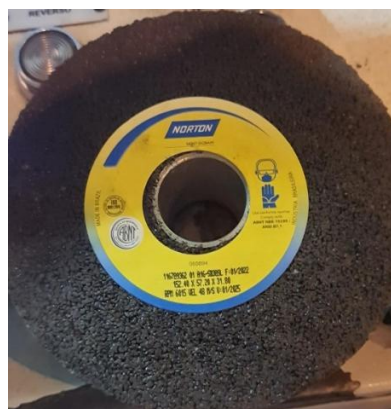
**Figure 4.3** - Grinding wheel used in the automatic repair operation on the inside pipe surface.

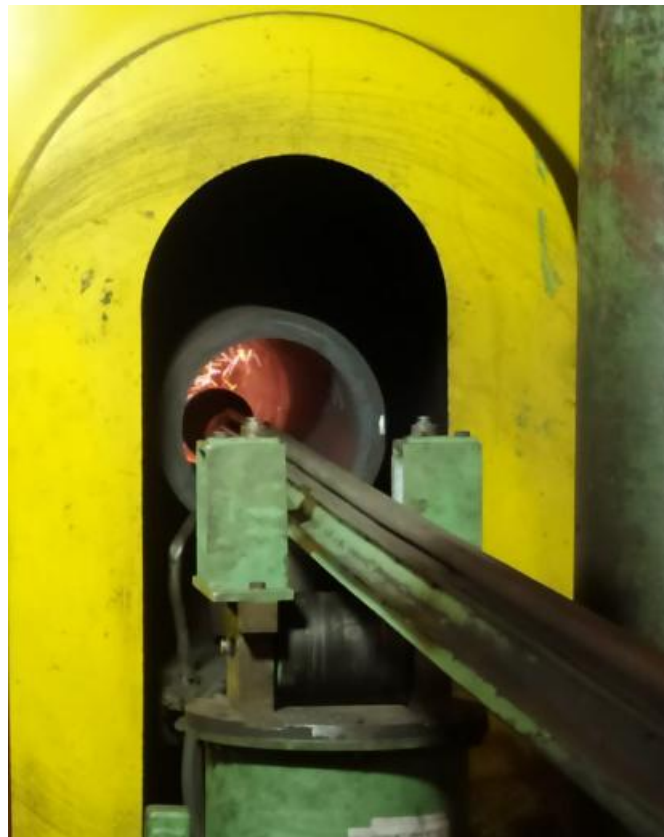
**Figure 4.4** - Grinding operation at the inner surface of the pipe.

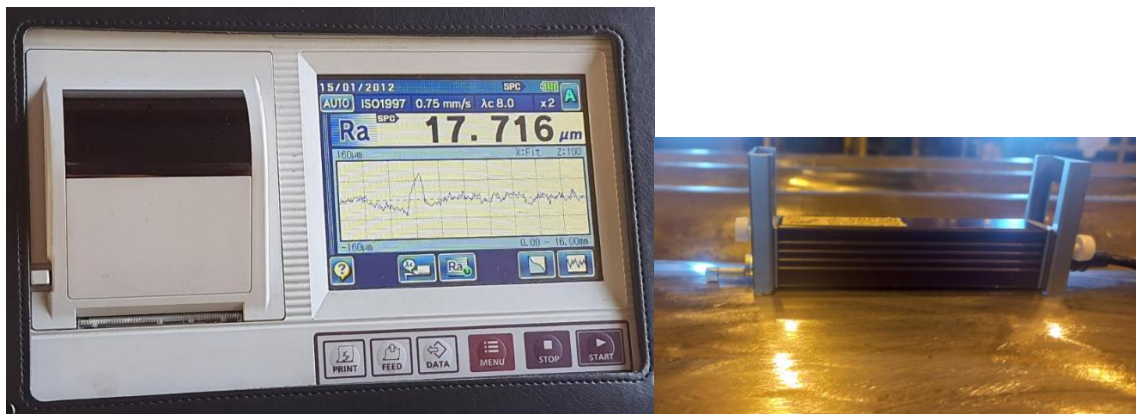
**Figure 4.5** - Rugosimeter used to measure the surface roughness of the seamless pipes

Roughness measurements were conducted at the outer surface on the samples removed from the middle of the pipe and on the area with the external grinding to assess the impact of the grinding operation in their tribological properties. The roughness was recorded using an automatic rugosimeter SJ-310 Mitutoyo (see Figure 4.5) certified according to ISO 1997. The measurements of the average roughness (Ra) were recorded longitudinally three time at each position. Four positions were considered along the perimeter of each pipe, separated by an angular distance of 90°.

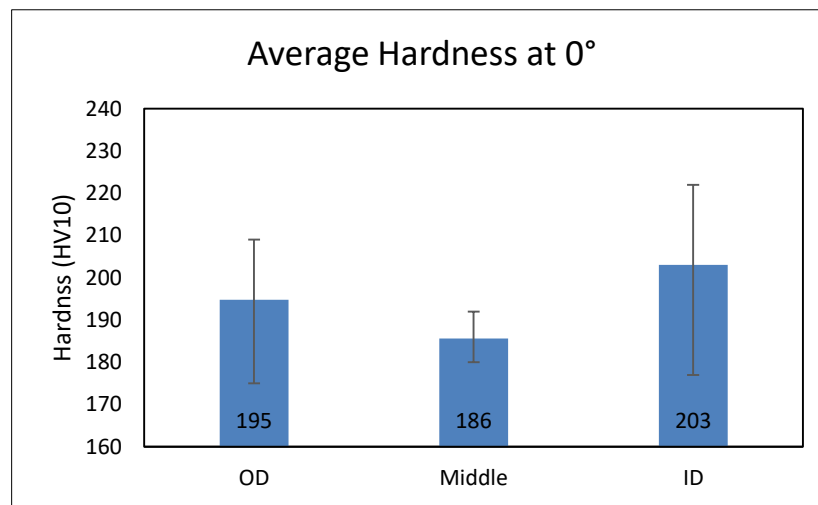
The hardness values were recorded using a Vickers indenter thickness of the tube at  $\theta = 0$  and  $180^{\circ}$ . The measurements were undertaken at a distance of  $\sim 1.5 \text{ mm}$  from the inner diameter, at the mid-thickness and at a distance of  $\sim 1.5 \text{ mm}$  from the outer diameter. Figures 5.1 and 5.2 display the average values of the Vickers hardness in each position, before grinding, together with bars indicating the minimum and maximum values recorded. According to API 5L, 2018, [5] the maximum hardness shall be 250 HV10. In this study, the hardness values did not exceed 222 HV10 at  $\theta = 0^{\circ}$  for the inner diameter position and 237 HV10 at  $\theta = 0^{\circ}$  for the outer diameter position. Therefore, all results of hardness are in accordance with API 5L, 2018.

**Figure 5.1** - Results of average hardness (HV10) in position 0° before grinding

Comparing the results of average hardness in the same position, it can be seen a small variation through pipe thickness, as it was obtained a variation of average hardness of 17HV10 in position 0° and 21HV10 in position 180°. Furthermore, comparing the results of average hardness in position 0° with in position 180°, it possible to notice that results are also similar, as for example, in the middle of the wall thickness, it was obtained the same average hardness.

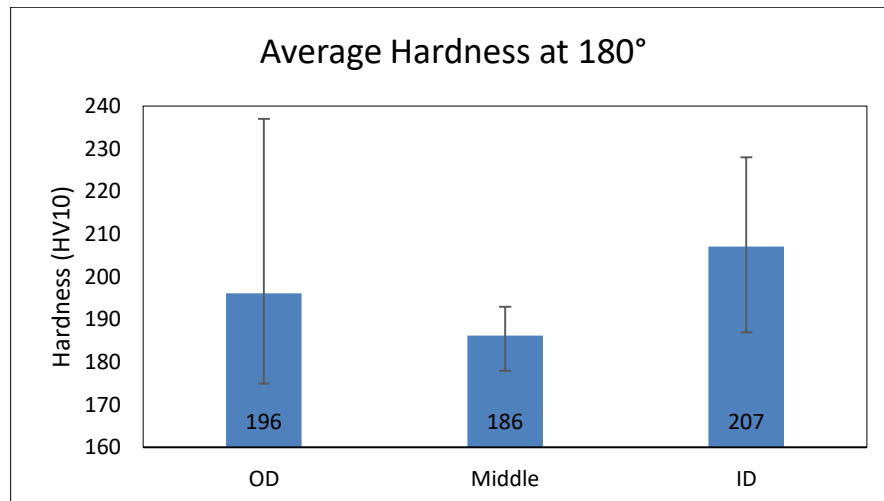
**Figure 5.2** - Results of average hardness (HV10) in position 180° before grinding

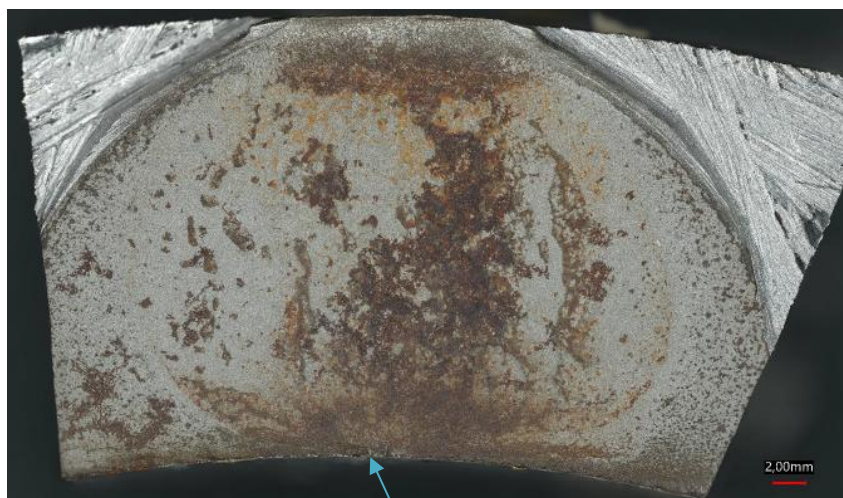
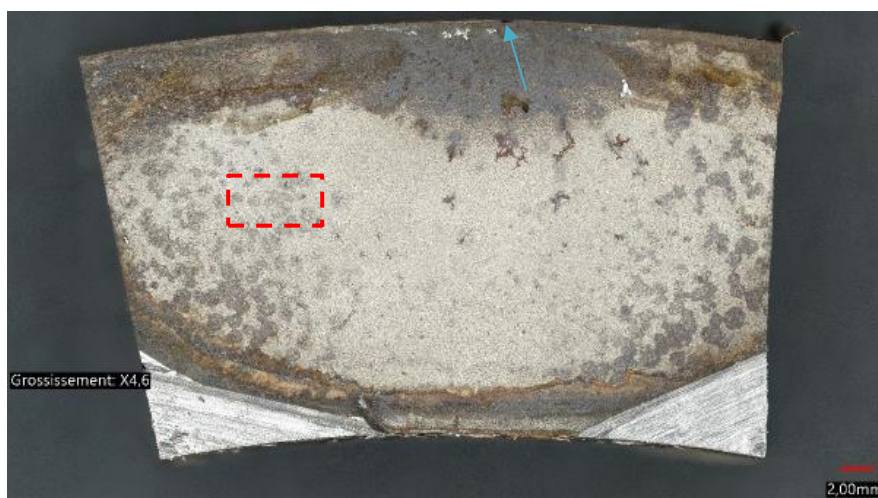
Each sample was then examined at the vicinity of the longest indication of MPI to produce a macrograph of the fracture surface. Figure 5.13 shows the macrographs of typical specimens for each surface condition: R159-04 (without grinding), R159-09 (with internal grinding), and R159-13 (with external grinding). The blue arrows indicate the location where the cracks originated.

The evaluation of macrographs revealed that the cracks originated from the internal surfaces and propagated towards the external surfaces in the majority of the seamless pipes, except for the unground specimen R159-03 (which had the longest fatigue life) and the specimens which external grinding, where the cracks started from the external surfaces and propagated towards the internal surfaces. Furthermore, all specimens exhibited the presence of typical lunulas.

**Figure 5.13** – Macrography in the fracture surface of specimen (a) R159-04 (without grinding); (b) R159-09 (with internal grinding) and (c) R159-13 (with external grinding). Presence of lunula. Arrows point to where the crack started

Evaluation with SEM was made in all specimens in at least two regions. The SEM analyses revealed the presence of fatigue striations in all specimens that were not highly oxidized. These fatigue striations are pointed by blue arrows in Figure 5.14 for the material which underwent internal (R159-09) and external (R159-13) grinding. It should be noted that the SEM images in Figure 5.14 were acquired within the red dotted area marked in Figure 5.13.
