Failure Mechanisms of Interlocked Bricks of Soil-Cement and Wood Fibers

Abstract— *The goal is to determine the mechanisms of soil-cement interlocked brick plus wood fibers under compressive loading. For this we used experimental stress analysis techniques. Horizontal deformations (ϵ_x) and vertical (ϵ_y) of bricks were obtained with extensometers, in the configuration of five rosettes. From the values of these deformations and using the equations of the theory of elasticity, Poisson coefficients were determined and elasticity modules, and calculated the corresponding voltages each escutcheon according to the equations of the State of plane stress. To determine the trajectory of the rupture voltage-loading graphics were made of each rosette. Knowing this trajectory determined the tensions related to the modification of the brick break mechanism. The appearance of a premature cracking or excessive is parameter used to determine the State limit of use of bricks.*

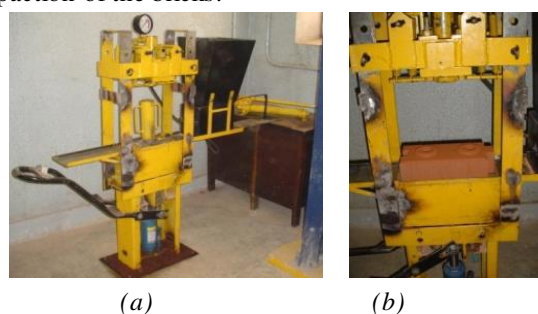
that it was possible to control pressure during the pressing. For this, it was instrumented with a manometer, which was calibrated with a ring dynamometer, thus enabling the conversion of the measure provided by the instrument for the measurement of compression pressure (2.0 MPa), Fig. 1. After molding, the bricks were ferried to the humid chamber where they remained for seven days at a temperature of 23 ± 0.2 °C and relative humidity around 100%.

Fig. 1: a) Brick molding press, b) Extraction of brick

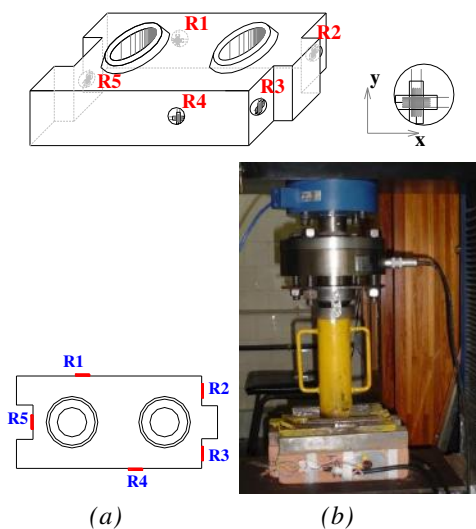
To catch the horizontal deformations (εx) and vertical (εy), the bricks were instrumented, each with five rosettes, formed by two strain gages (one vertical and one horizontal), at locations shown in Fig. 2a.

The instrumented bricks were tested with compressive loading applied and monitored by means of a load cell, Fig. 2b.

Fig. 2: a) Position and numbering of the rosettes on the brick Interlocked, b) Compression test
