## **Successful outcome of surgical reintervention for implant placement in borderline aesthetic area related to agenesia: a case report**

The aim of this study is to illustrate and discuss the fundamentals of a well-succeeded and minimally invasive technique of surgical reintervention for installing implant in the reduced area of the alveolus, affected by agenesia, and traumatized by an unsuccessful intervention. Materials and methods: A 27-year-old patient sought dental care and her main cause was the great dissatisfaction with the aesthetic sequelae in the region of the right upper lateral incisor, in addition to the uncertainty regarding the predictability of a new unitary implant. Imaging exams showed trauma in the middle and apical region of the canine root surface. The dimensions of the edentulous area varied between 4.6 and 5.52 mm. A small diameter implant (BLT 2.9mm SC, Loxim SLActive® 12 mm, TiZr - Straumann Dental Implant System) was planned and installed, in addition to a subepithelial connective graft. Results: The results achieved allowed to restore the desired function and aesthetics, with excellence, low morbidity, in addition to a predictability favored by the be

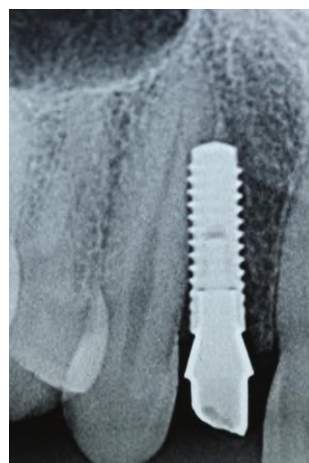
The patient had postoperative periapical radiographs, and it was possible to visualize the presence of an implant, which was located in the middle third of the right superior canine mesial root surface and was facing the coronary third. The distal proximal surface of the right upper central incisor was preserved (Figure 1). The patient recalled that she felt severe pain in the postoperative period, and the implant was removed at this point in the patient's treatment course. She also reported good overall health.

**Figure 1:** X-ray image evidencing failure in the initial implant position.

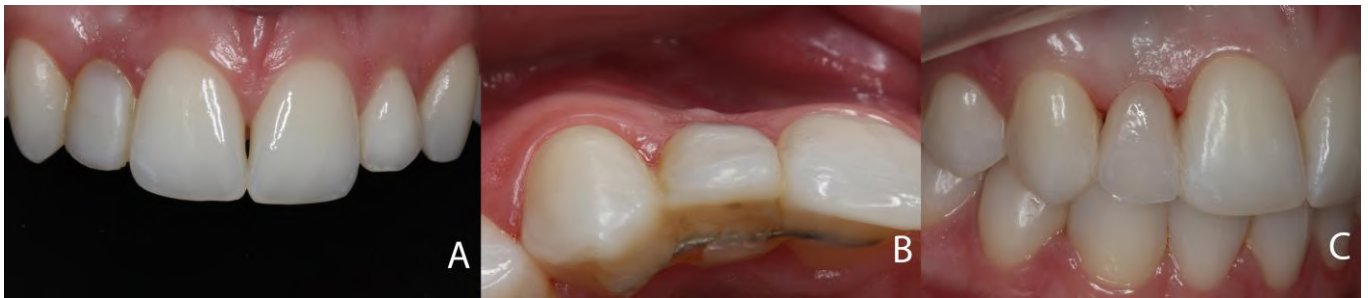
In the clinical examination, a resin adhesive prosthesis was glued to the adjacent teeth with the aid of an orthodontic wire and composite resin, and the tissue margins appeared swollen. Because of the complaints and observed conditions, the prosthesis was removed, and a new adhesive prosthesis was initially made to promote hygiene and emotional comfort for the patient (Figures 2a, 2b and 2c).

**Figure 2:** 2a- initial front view of the smile; 2b- incisal view of the initial resin adhesive prosthesis; 2c- new resin adhesive prosthesis in place.

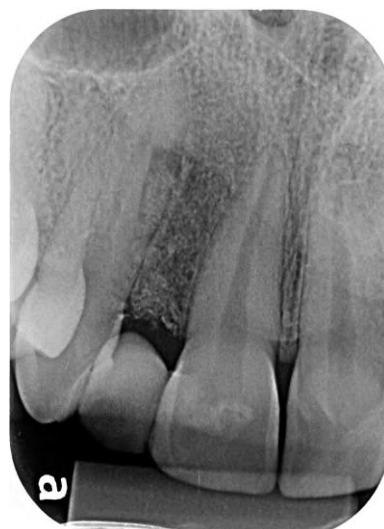
Subsequently, a periapical radiographic examination of the area was requested, showing an interruption of the peri-cement line and a radiolucent area in the middle third of superior right canine, suggesting external root resorption. This finding was asymptomatic due to a lack of pulp involvement. In this case, external root resorption was caused by the loss of dental structure, which was generated by contact of the implant with the root structure. Additionally, the presence of trabecular bone in the whole implant socket was noted (Figure 3).

**Figure 3:** X-ray image revealing interruption of the peri-cement line, radiolucent area in the middle third of the tooth 13, and presence of trabecular bone in the implant socket.

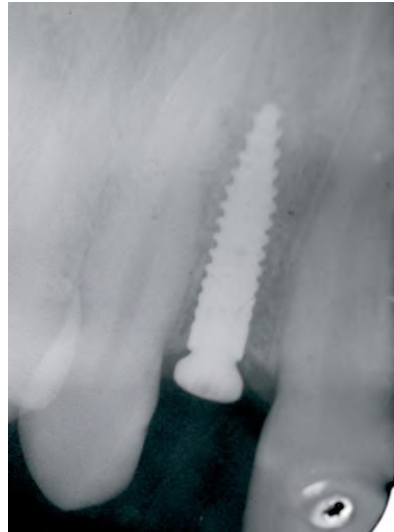
To stabilize the subepithelial graft, a periosteum suture in the middle third of the keratinized mucosa, as well as two simple sutures in the region of future papillae, was performed. At the end, a periapical radiograph was performed by the parallelism technique, and the radiograph confirmed perfect positioning of the implant in relation to the adjacent natural pillars (Figure 5).

**Figure 5:** X-ray image evidencing correct implant positioning.

The implant (BLT 2.9 mm SC, Loxim SLActive® 12 mm, TiZr - Straumann Dental Implant System) was installed with ratchet assistance, and high primary locking was obtained. A ½ mm locking screw was installed.

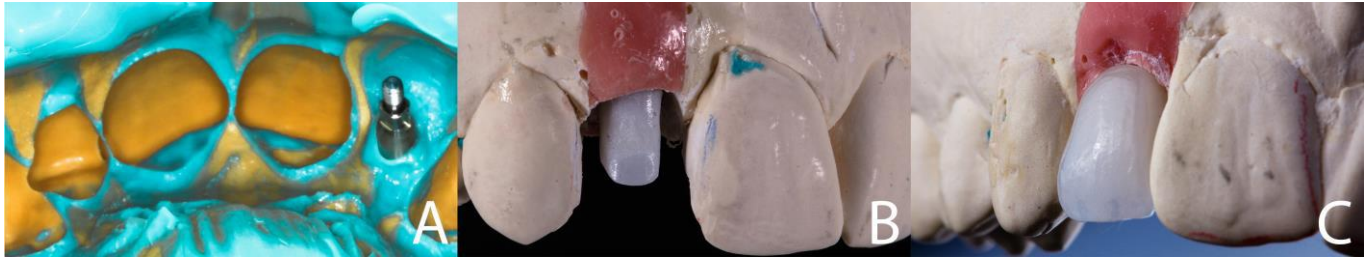
In the following session, after gingival conditioning occurred, the provisional restoration was removed, and the implant head was transferred with vinyl polysiloxane (Panasil, Ultradent) (Figure 5). The antagonist arch was molded with an irreversible hydrocolloid impression material. The models were created in type IV stone plaster. A titanium abutment was customized using zirconia (Zr Armann Girrbach), and a lithium disilicate monolithic ceramic crown (IPS e.max Ceram, Ivoclar Vivadent) was built on the abutment (Figure 8a, 8b and 8c).

**Figure 8:** **8a-** VPS impression with transfer. **8b-** Titanium abutment customized with zirconia. **8c-** final lithium disilicate crown.

A torque of 32 newtons was applied to the abutment screw, as recommended by the manufacturer. The screw access cavity was sealed with Teflon tape.

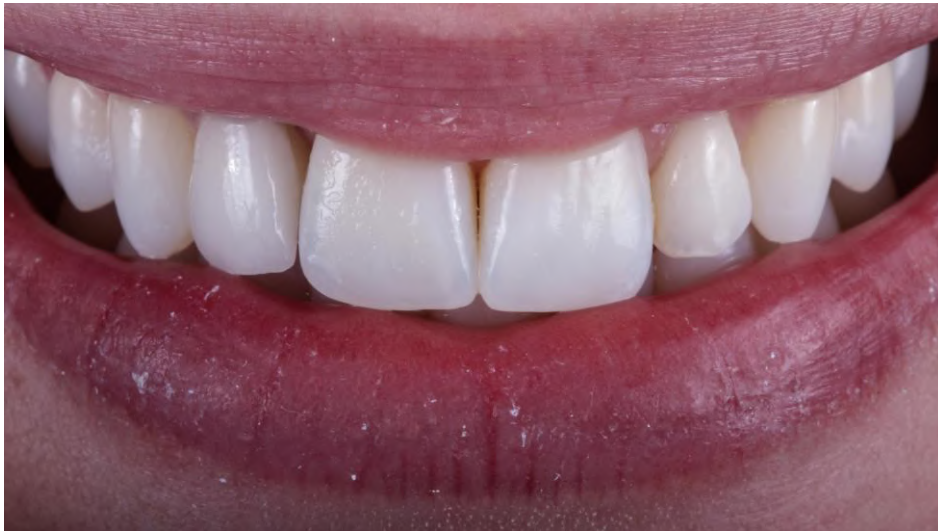
Thus, it was possible to complete the processes required to restore the soft tissue health, dental aesthetics, and self-esteem of the patient (Figure 9). After 12 months postoperatively, positive conditions related to the stability and health of the gingival margins, as well as a favorable implant response to the imposed loads, were noted (figure 10). Annual visits to control the tissue margin stability and implant conditions and to understand the behavior and longevity of the small-diameter implant considered here were suggested for the patient.

**Figure 9:** Final view of the smile.

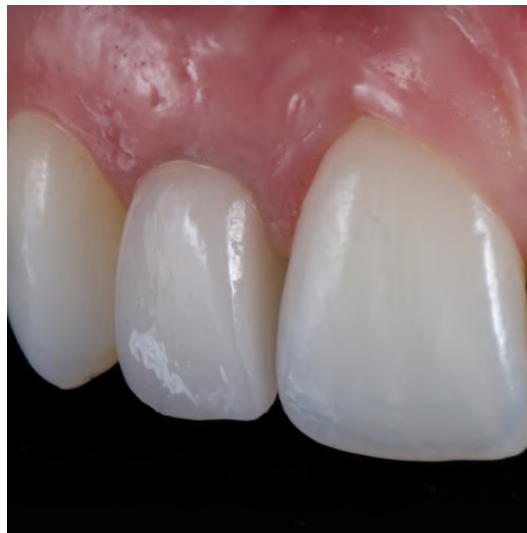
**Figure 10:** Final aspect of the implant and crown restoration evidencing healthy gingival margins.
